Manhole Inspection Summary

Manhole # S25CC_063MH

Insp Date: **7/19/07 10:24 AM**

Location Address: **1203 SMITHSON ST**

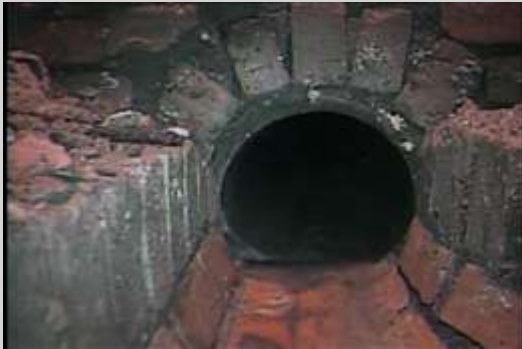
12 O'Clock Outflow

8 in. Circular Gravity Sewer
Pipe Out @ 12 O'Clock

Pipe Height: **7.2** (in.) Rod and Bar (Angled)
Pipe Material: **Clay** ☐ Pipe Lined
Invert Depth: **10.31** (ft.) Flow Characteristics: **Slow**
Deposits: ☒ None ☐ Mud ☐ Sludge ☐ Debris ☐ Grease
Silt Depth: (in.) Deposits Extent:
Infiltration: **None** Pipe Seal Cond: **Sound**

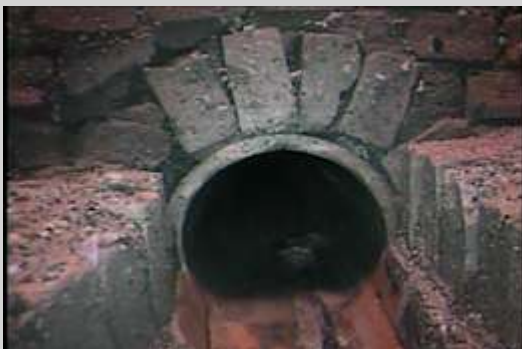
3 O'Clock Inflow

8 in. Circular Gravity Sewer
Pipe In @ 3 O'Clock

Pipe Height: **7.2** (in.) Rod and Bar (Angled)
Pipe Material: **Clay** ☐ Pipe Lined
Invert Depth: **10.22** (ft.) Flow Characteristics: **Slow**
Deposits: ☒ None ☐ Mud ☐ Sludge ☐ Debris ☐ Grease
Silt Depth: (in.) Deposits Extent:
Infiltration: **None** Pipe Seal Cond: **Sound**
